Fire Risk Assessment Stockwood Gardens

Version 2

22 February 2023

Ref: J025761

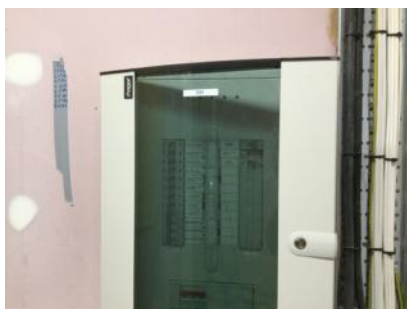
New electrical installations present. Ensure interval inspections do not exceed 5 years in accordance with BS 7671.

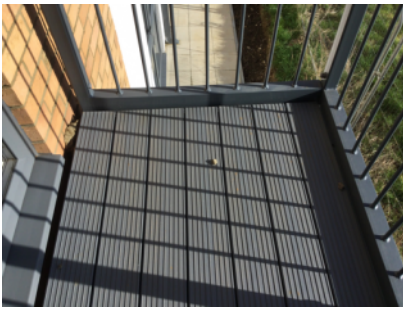
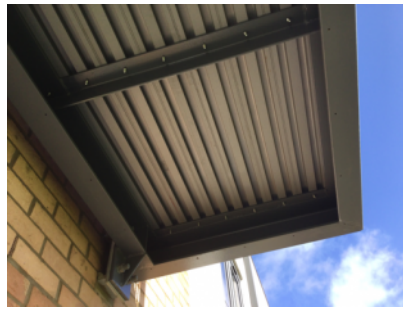
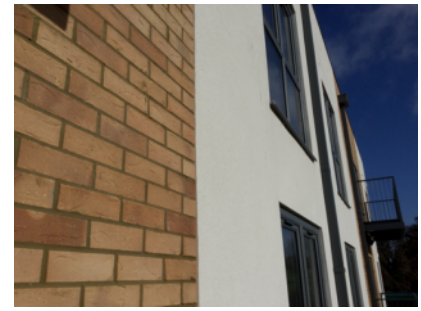
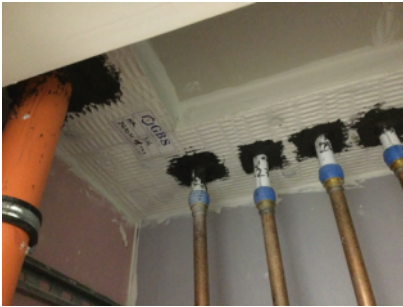
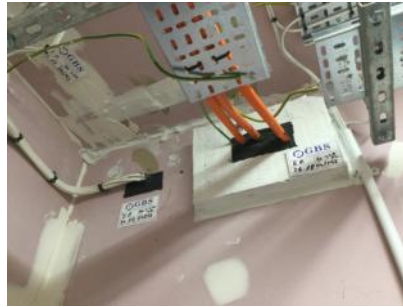
Overall compartmentation within the premises was adequate with evidence of internal passive fire protection completed by GBS Fire Protection Ltd. The riser within the third floor of Heather Block was identified with a breach to the ceiling.

The external envelope of the premises comprised of a render onto block and metal cladding to block work, as this property has been constructed in 2022 in line with current building regulations no issues expected with fire spread to the external envelope of the premises at the time of inspection.

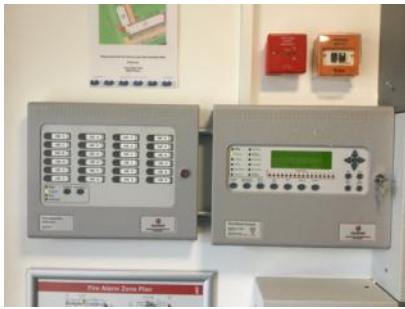
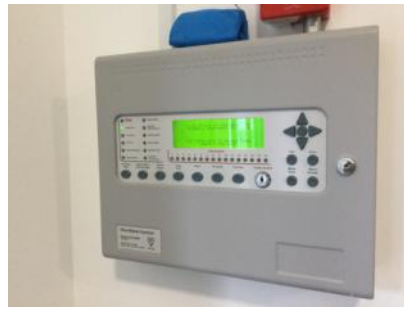
Fire system control equipment was suitably placed adjacent to the main entrance and clearly visible within each block.

Following previous risk assessment the fault provided to the control equipment located to Heather block has now been rectified, and the control equipment was found to be fault free and clear at the time of inspection.

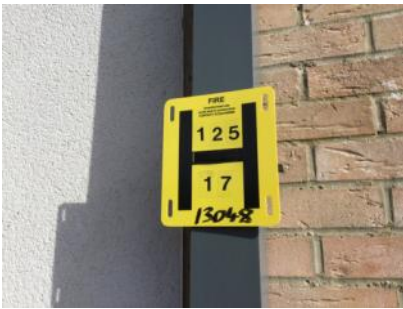
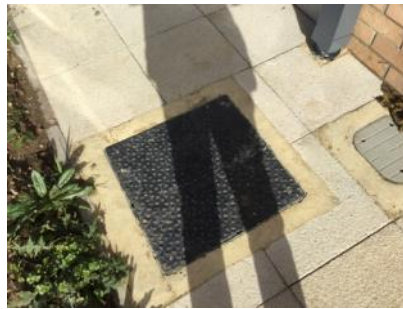
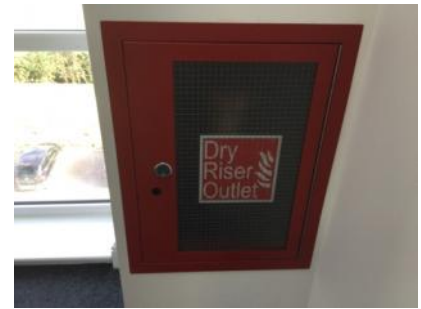
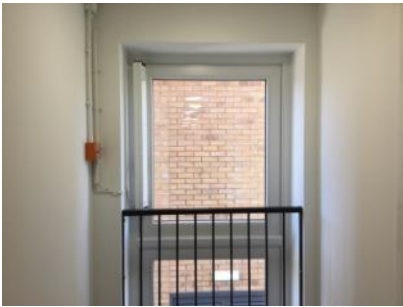
Hydrant location is to the rear of Heather Block

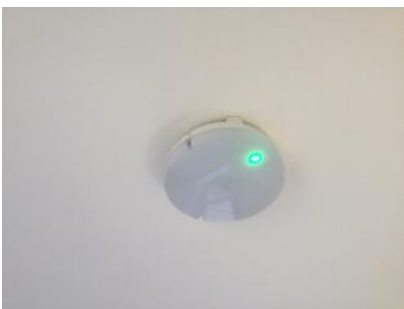
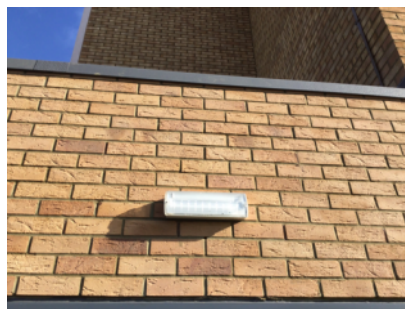
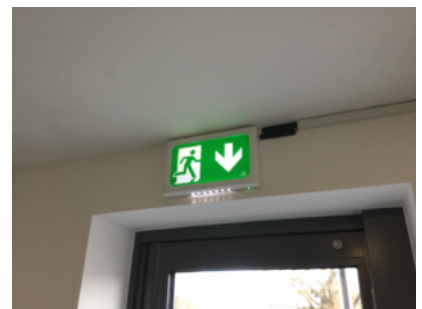
The level of emergency escape lighting was considered adequate and appeared to be installed in accordance with BS 5266.
