Fire Risk Assessment

Full Property Name	The Wharf (Purpose Built Apartments).
Full Property Address:	27 Wharf Road, Altrincham WA14 1AP.
Number of floors	Five floors, including the ground.

Assessment Date:	11 th of July 2023
Assessor's Name:	G Hodson EngTech, MIFireE, MIFSM.
Responsible Person:	Wharf Road, Management Limited. (Property managed by Manchester property group Limited.)
Occupancy Type:	Purpose-built flats - common areas
Is the Regulatory Reform Fire Safety Order applicable to this building?	Yes
Risk Level for Building at Time of Inspection (Overall Risk Rating) 1 (high), 2 (medium), 3 (low)	Medium
Suggested Risk Assessment Review Date:	July 2024

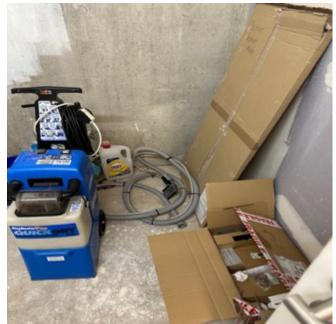
Picture 4

2.1.2 - 2.1.4	There is some electrical equipment provided in the communal area storerooms and service rooms. There is CCTV equipment, and several hoovers were noted. It is unclear if these belong to the building company or cleaners if they belong to the building or cleaners, they require PAT testing. See pictures. 3,4,5.

2.1.2	There is some electrical equipment provided in the communal area storerooms and service rooms. There is CCTV equipment, and several hoovers were noted. It is unclear if these belong to the building company or cleaners if they belong to the building or cleaners, they require PAT testing.	3	Management		Comply with recommendations opposite.

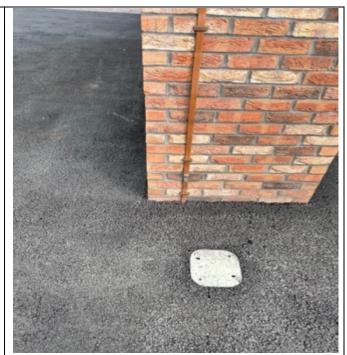
Picture 6

2.1.5	Lightning protection has been provided to the building. Ensure this is tested regularly as recommended by the installers. See picture. 6.

2.1.5	Lightning protection has been provided to the building.	3	Management		Ensure this is tested regularly as recommended by the installers.

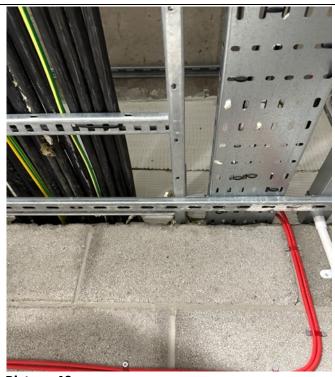
Picture 40

There appear to be holes in fire resistance, where pipes and cables of pass through the wall within the pump room fire stopping has been damaged. See picture 40.

3.2.1	Repair the holes in fire resistance within the ground floor lobby. There appear to be holes in fire resistance, where pipes and cables of pass through the wall within the pump room fire stopping has been damaged. Upper floors Within the cleaner's cupboard. There is a damaged area of wall where plasterboard has been damaged by the door handle. This requires repairing. It requires confirming that the walls within this room got a full ceiling height as there appear to be gaps if this is the case it requires fire stopping. Where the soil pipe passes through the floors it is unclear if the fire stopping is up to standard. Within the service room on first floor, do not appear to be any smoke seals fitted to the door. There is an intumescent strip.	2	Management		Holes in floors/walls are to be infilled with fire resisting materials to afford at least the same degree of fire resistance as the existing floor/wall. Fit fire, stopping as required and strips of seals, as indicated opposite were missing.

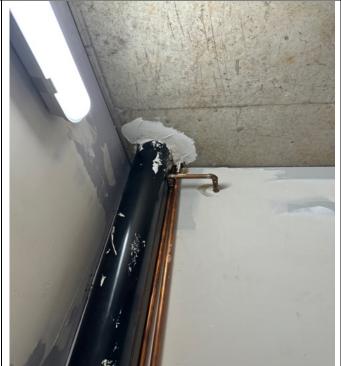
Picture 42

Within the cleaner's cupboard. There is a damaged area of wall where plasterboard has been damaged by the door handle. This requires repairing. It requires confirming that the walls within this room got a full ceiling height as there appear to be gaps if this is the case it requires fire stopping. Where the soil pipe passes through the floors it is unclear if the fire stopping is up to standard. See pictures.41,42.
