Fire Safety Risk Assessment

Chestnut Apartments
4 Gorse Road
Stockwood Gardens
Luton
Bedfordshire
LU1 4GG

Assessment Date: 12th February 2025

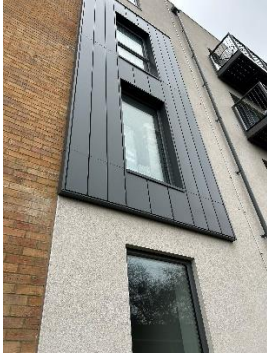
There is a small area of cladding at the front of the building for decorative purposes. This appears to be metal framed with metal board fascia. It covers an area approximately 15m squared. The assessor has requested information on the materials fire resistance, what is behind the cladding and if fire stopping can be confirmed between floors. No information has been forthcoming. The area is not large but the fire resistance of the material should be confirmed by the responsible person and that fire stopping required between floors has been carried out.

<p>Chestnut Apartments</p>	<p>Example of cladding used on building. The responsible person must confirm fire stopping has been completed between floors behind the cladding and that the fascia material used will not facilitate fire spread</p>

The fire resistance of the material used on the outside of the building should be confirmed by the responsible person to ensure it does not facilitate fire spread and that any fire stopping required between floors has been completed.

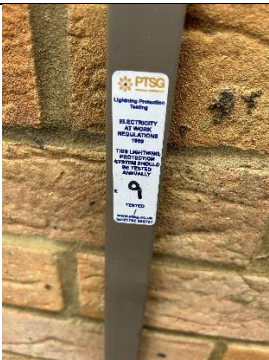
Lightning protection tested annually by PTSG

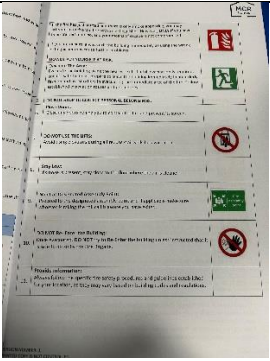
<p>Example of the incorrect fire safety information given to residents instructing them to use extinguishers to fight a fire in their apartment</p>	<p>Example of the adhesive strip covering the intumescent strip and smoke seal, it should be removed and the door returned to the required fire resisting standard FD30S</p>

- The fire safety information supplied to the residents should be corrected and the correct procedure communicated to residents.
- PIB boxes have been installed on the ground floor and it is recommended that they contain the following information as a minimum to assist the Fire Service:
- A logbook for the purpose of recording events
- A copy of the evacuation strategy supplied to residents
- Information on residents with mobility, cognitive or sensory impairments

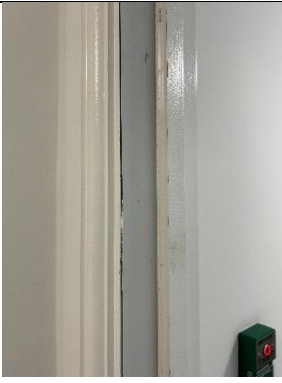
Fire doors to lobbies and communal areas are fitted with intumescent strips and smoke seals and most were operating effectively at the time of the assessment. On inspection it was noted that some of the communal fire doors had an adhesive strip covering the intumescent strip and smoke seal. The adhesive strips should be removed and the fire door brought up to the required fire resisting standard FD30S.

- The adhesive strips should be removed and the fire doors brought up to the required fire resisting standard FD30S
- The communal fire doors should have a three month fire door inspection completed and any actions noted should be completed
- The apartment front doors should have an annual inspection completed and any actions noted should be completed
