Fire Safety Risk Assessment

Ivy Apartments
7 Gorse Road
Stockwood Gardens
Luton
Bedfordshire
LU1 4GL

Assessment Date: 12th February 2025

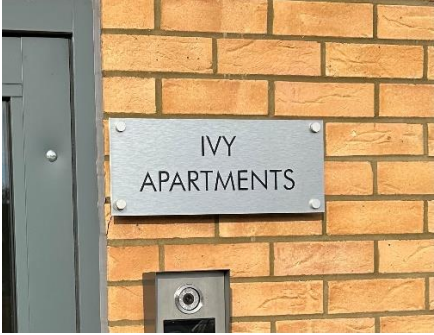
There is a small area of cladding at the front of the building for decorative purposes. This appears to be metal framed with metal board fascia. It covers an area approximately 15m squared. The assessor has requested information on the materials fire resistance, what is behind the cladding and if fire stopping can be confirmed between floors. No information has been forthcoming. The area is not large but the fire resistance of the material should be confirmed by the responsible person and that fire stopping required between floors has been carried out.

Ivy Apartments	Example of balconies constructed of metal and decorative cladding

The fire resistance of the material used on the outside of the building should be confirmed by the responsible person to ensure it does not facilitate fire spread and that any fire stopping required between floors has been completed.

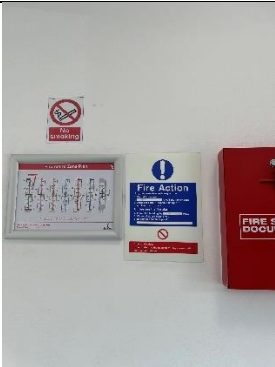
<p>Example of the incorrect fire action notice as a stay put policy is in place and also no fire extinguishers are provided or required</p>		<p>An AOV system next to the firefighting lift. This should be inspected as required along with all the AOV systems</p>

- The fire safety information supplied to the residents should be corrected and the correct procedure communicated to residents.
- PIB boxes have been installed on the ground floor and it is recommended that they contain the following information as a minimum to assist the Fire Service:
- A logbook for the purpose of recording events
- A copy of the evacuation strategy supplied to residents
- Information on residents with mobility, cognitive or sensory impairments
