Fire Safety Risk Assessment

Snowdrop Apartments
5 Gorse Road
Stockwood Gardens
Luton
Bedfordshire
LU1 4GH

Bonum Safety Services Ltd
on behalf of
VIR Electrical Ltd

Assessment Date: 12th February 2025

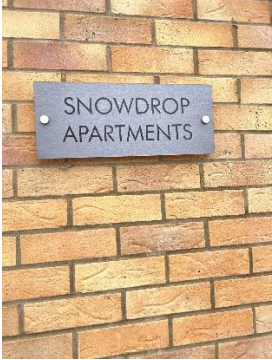
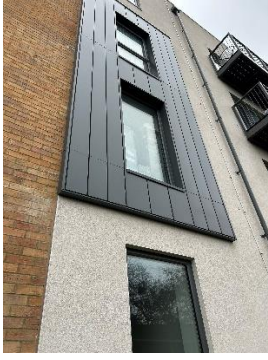
There is a small area of cladding at the front of the building for decorative purposes. This appears to be metal framed with metal board fascia. It covers an area approximately 15m squared. The assessor has requested information on the materials fire resistance, what is behind the cladding and if fire stopping can be confirmed between floors. No information has been forthcoming. The area is not large but the fire resistance of the material should be confirmed by the responsible person and that fire stopping required between floors has been carried out.

<p>Snowdrop Apartments</p>		<p>Example of cladding used on building. The responsible person must confirm fire stopping has been completed between floors behind the cladding and that the fascia material used will not facilitate fire spread</p>

The fire resistance of the material used on the outside of the building should be confirmed by the responsible person to ensure it does not facilitate fire spread and that any fire stopping between floors has been completed.

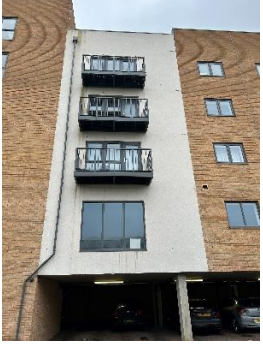
<p>Example of balconies constructed of metal</p>

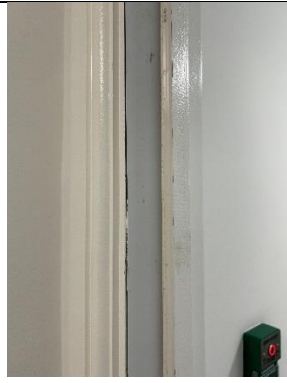
Fire doors to lobbies and communal areas are fitted with intumescent strips and smoke seals and most were operating effectively at the time of the assessment. On inspection it was noted that some of the communal fire doors had an adhesive strip covering the intumescent strip and smoke seal. The adhesive strips should be removed and the fire door brought up to the required fire resisting standard FD30S.

<p>Example of the incorrect fire safety information given to residents instructing them to use extinguishers to fight a fire in their apartment</p>	<p>The adhesive strip covering the intumescent strip and smoke seal should be removed and the door returned to the required fire resisting standard FD30S</p>

- The adhesive strips should be removed and the fire doors brought up to the required fire resisting standard FD30S
- The communal fire doors should have a three month fire door inspection completed and any actions noted should be completed
- The apartment front doors should have an annual inspection completed and any actions noted should be completed

- The fire safety information supplied to the residents should be corrected and the correct procedure communicated to residents.
- PIB boxes have been installed on the ground floor and it is recommended that they contain the following information as a minimum to assist the Fire Service:
- A logbook for the purpose of recording events
- A copy of the evacuation strategy supplied to residents
- Information on residents with mobility, cognitive or sensory impairments
