Fire Safety Risk Assessment

White Rose Apartments
2 Gorse Road
Stockwood Gardens
Luton
Bedfordshire
LU1 4GE

Bonum Safety Services Ltd
on behalf of
VIR Electrical Ltd

Assessment Date: 12th February 2025

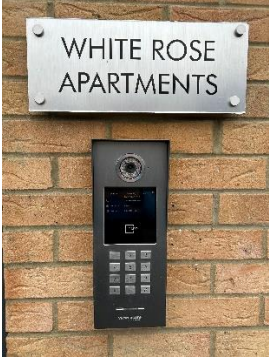
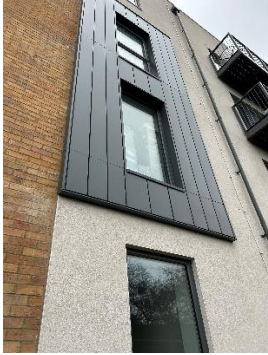
| <p>White Rose Apartments</p> | <p>The responsible person must confirm fire stopping has been completed between floors behind the cladding and that the fascia material used will not facilitate fire spread</p> |

| HEIGHT OF BUILDING | YES / NO |
|---|---|
| Is a EWS1 Survey Required? | NO. However the responsible person must confirm that any fire stopping behind the cladding and between floors has been carried out as required. |

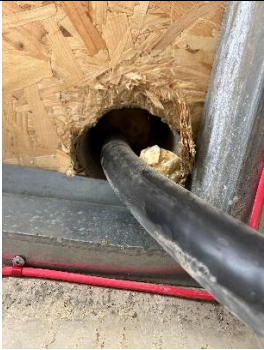
Fire stopping has been completed throughout the building by GBS Fire Protection Ltd; however, several breaches were noted in the sprinkler room on the ground floor, the ground floor waste storage area and a riser cupboard. Also, water was coming through some fire stopping located on the roof of the under cloak carpark. This is obviously causing damage to the fire stopping. All breaches in compartmentation must be suitably fire stopped using an approved material and any water damaged fire stopping must be repaired.

| <p>Example of breach in sprinkler room ceiling that requires fire stopping</p> | <p>Example of breach in riser cupboard that requires fire stopping</p> |

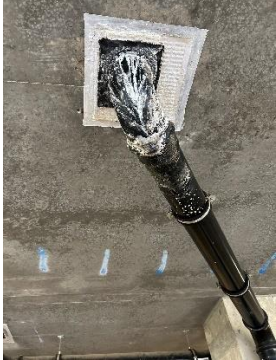
| <p>Water damaged fire stopping on ceiling of under cloak car park that requires attention</p> | <p>Signage required to denote sprinkler room</p> |

| ITEM # | ACTION | RISK RATING |
|---|--|---|
| 7. | The water coming through the fire stopping in the under cloak car park should be remedied and the fire stopping repaired | Substantial |

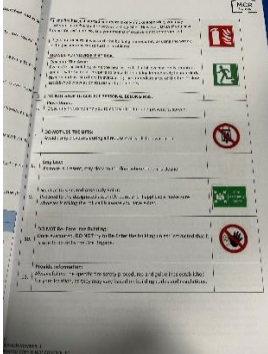
| <p>Example of the incorrect fire safety information given to residents instructing them to use extinguishers to fight a fire in their apartment</p> | |

- The fire safety information supplied to the residents should be corrected and the correct procedure communicated to residents.
- PIB boxes have been installed on the ground floor and it is recommended that they contain the following information as a minimum to assist the Fire Service:
- A logbook for the purpose of recording events
- A copy of the evacuation strategy supplied to residents
- Information on residents with mobility, cognitive or sensory impairments
