Fire Risk Assessment

Full Property Name	The Wharf (Purpose Built Apartments).
Full Property Address:	27 Wharf Road, Altrincham WA14 1AP.
Number of floors	Five floors, including the ground.

Assessment Date:	11 th of July 2023
Assessor's Name:	G Hodson EngTech, MIFireE, MIFSM.
Responsible Person:	Wharf Road, Management Limited. (Property managed by Manchester property group Limited.)
Occupancy Type:	Purpose-built flats - common areas
Is the Regulatory Reform Fire Safety Order applicable to this building?	Yes
Risk Level for Building at Time of Inspection (Overall Risk Rating) 1 (high), 2 (medium), 3 (low)	Medium
Suggested Risk Assessment Review Date:	July 2024

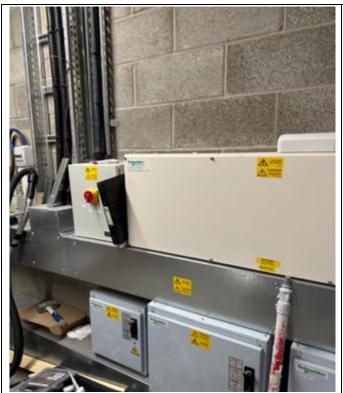
Picture 1

2.1.1	The main electrical service room is contained off the main carpark on the ground floor. Within each flat there are distribution boards. As the building is recently constructed, the fixed wiring test should be compliant. No paperwork was provided. See pictures 1,2. The electrical fixed wiring test for the Landlord's supply should be carried out by a competent electrical engineer in accordance with BS 7671. An inspection every five years is recommended for the main electrical intake for the building. A management procedure should be implemented to ensure that the relevant fixed wiring tests are carried out at the appropriate time. The Engineers reports should be retained as evidence of the tests.

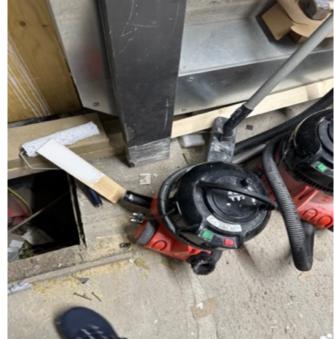
Picture 4

Storage is taking place within these rooms. Excess rubbish and builders' storage requires clearing from both the cleaner's rooms and the service shaft rooms. First floor. See picture. 4,20.

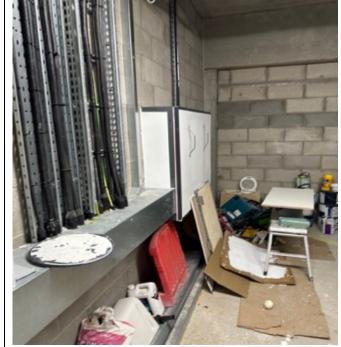
Picture 12

2.5.1 - 2.5.10	Ground floor On the ground floor beneath the building is located a car parking area for residents. This also extends to the rear and left-hand side of the building. Within this car parking area are several EV charging points located beneath the building. There is fire detection within the car park and the ceiling of the car part it is a compartment ceiling. Located towards the front of the car park when looking from the front of the building are two rooms with compartment walls going to full ceiling height they contain an electric room with the main incoming supply, and a separate sprinkler pump room containing the sprinkler water tank and associated pumps. The main room containing electric incoming supply is essentially used as a storeroom at present.	
	It requires clearing out builder's rubbish is stored within here as well as rubbish down the main incoming electrical supply pit. See pictures. 12,13,14,15.

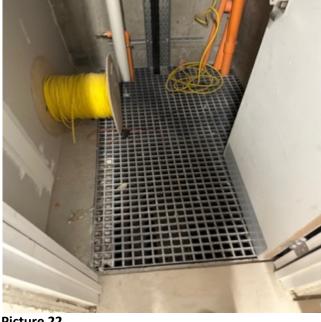
Picture 21

There are fire doors at the end of each service room on each level to a service shaft. This should be kept sterile storage should not take place on the metal grills. See example picture. 21. Level 4 service shaft off service room. See picture 22. Level 5 service shaft off service room. See picture 23.

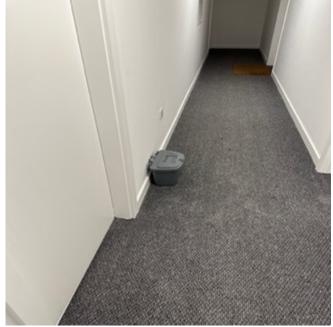
Picture 24

The housekeeping within the block is generally good. However, across various levels storage is taking place in the corridor that should be monitored and managed as it will likely get out of hand. See pictures.24,25.

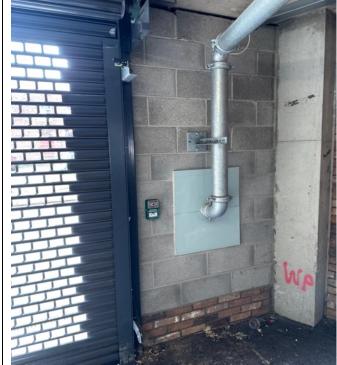
Picture 30

Comments and Other Relevant Issues Noted: (list)
3.1.2- 3.1.9	The vehicle access to the car park is via roller shutter door that works on fob access. There is, however, a green manual brake glass override and what appears to be manual chains to open the door. See pictures. 30,31.
	The bin room is located off the corridor mentioned above the final exit from the bin room to outside consist double doors with a maglock fitted these doors are for moving the bins onto the street prior to emptying. These doors are fitted with a green brake glass override. See picture 32.
	Within the building, there are several service rooms. This includes the pump room and electric room on the ground floor. These are kept locked and fitted with thumb turns on the inside. The thumb turn within the plant room requires reinstating as it is missing off the door. See picture.33
	The only flat that could be accessed was flat 31, it is fitted with a thumb turn to exit the rest of the flat door doors appeared identical. This requires confirming.

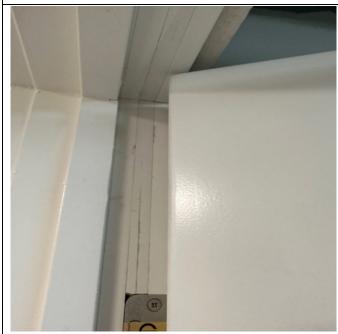
Picture 44

The door between the service room, and the service shaft appears to be fitted with excessive use of expanding foam. This door is a fire door face stopping as required around the door. There are no smoke seals fitted to the shaft door. See picture.44
