# **FIRE RISK ASSESSMENT**

**Division House  
87 Division Street  
Sheffield  
S1 4LX**

## Fire Risk Assessment

Division House  
October 2024

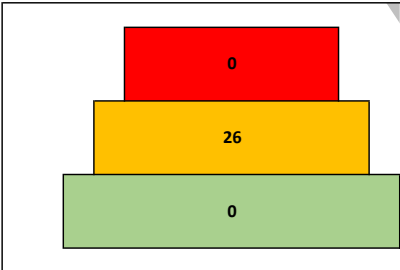
**Surveyed Door Grade Profile**

Total Doors	Surveyed	% Complete	No Access	Not Surveyed
27	26	96%	1	0

Door Grades

C
	B
	A
