FIRE RISK ASSESSMENT

Stockwood gardens

Heather Apartments-Block I, Newlands Road, Luton, Bedforshire, LU1 4GB VALID BETWEEN 10/04/2024 - 10/04/2025

ASSESSMENT REF. RB-62AE8Q

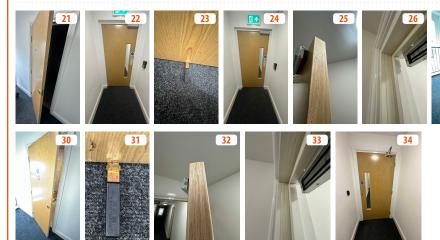
During the assessment, defects on the majority of fire doors were noted.

- -Fire strips/seals were missing.
- -Door gap tolerance exceeded.

The doors were not considered to be suitable and sufficient.

Suitable and sufficient doors are to be of FD30S specification, complete with a minimum of 3 fire rated hinges, a

self-closing device, intumescent strips, cold smoke seals with no excessive gaps to the top and sides of the door frame and to the underside of the door.

It is advised to task a qualified contractor to carry out a door survey and implement the correct remedial works such as upgrading/replacing all defected doors.
